# Successful revamping of existing processing lines in record time

Tenova Presind Automation (Techint Group) revamped and modernized the electrical and automation equipment of the No. 1 pickling line at the Dufenco plant in La Louvière, Belgium. The order comprised the revamping of the automation and drives for the entire line within a very tight schedule: during the two-week plant shutdown in August 2006.

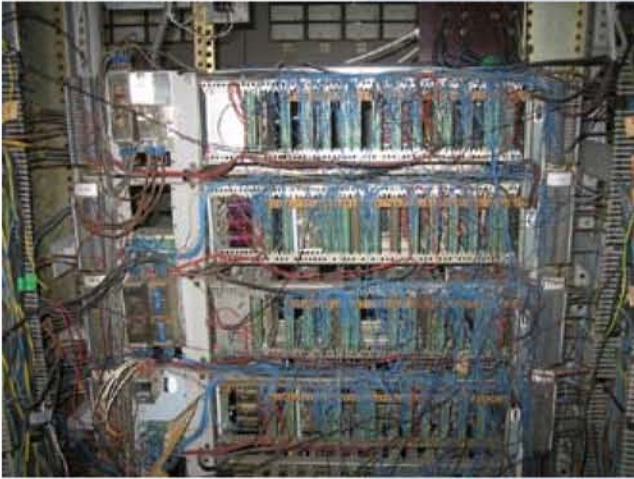
The plant had been active for about 30 years and had undergone many changes and additions, but always on a piecemeal basis. Due to the lack of reliable and updated documentation re-engineering presented a highly challenging task to Presind. Specifically, there was only very little information about the interfaces between the original plant and the PLCs installed over the years. Figures 2 and 3 give an impression of the status of the equipment before revamping.

**Figure 2.** One of the main difficulties was to identify the cables and their wiring schemes

diagrams were missing or incomplete, one of the main difficulties was to identify the cables and their wiring schemes.

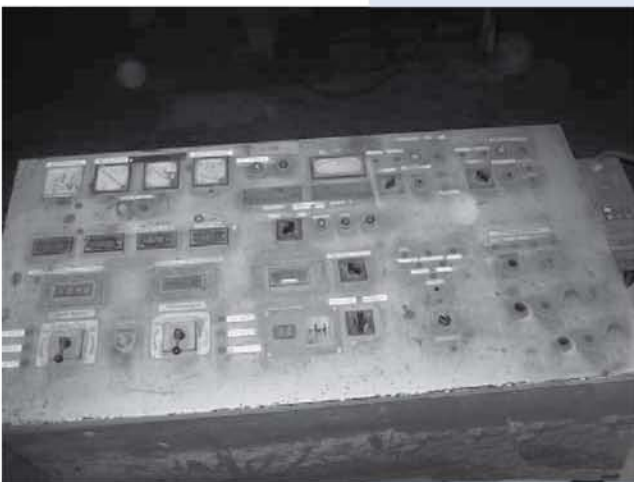
**Figure 3.** Before the revamp the plant had been in operation for 30 years

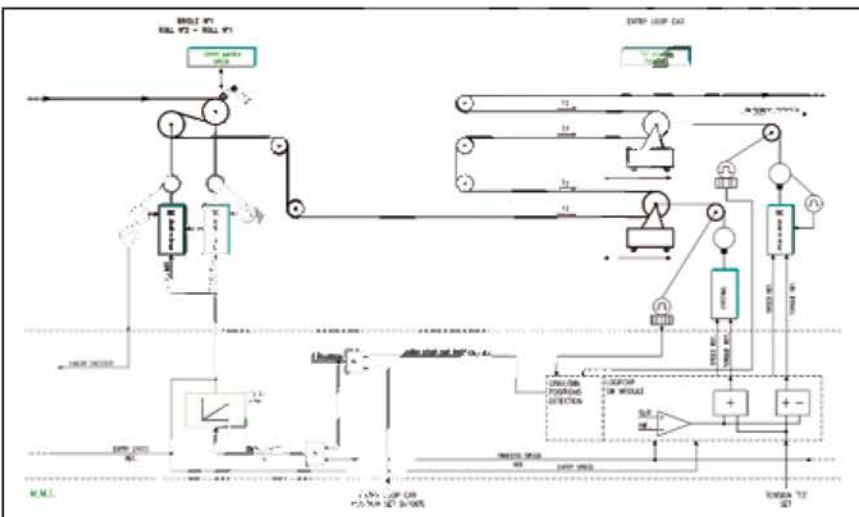
**Figure 4.** New automation scheme of the entry looper cars

The efficiency of the speed and torque control was improved leading to a significant reduction in line shutdowns due to rope breaking of the entry looper cars; before revamping this had occurred 2-3 times a month, afterwards this problem disappeared.

New pulse generators for speed control replaced the existing tachometers to serve as feed-back to the new digital drives. New automation architecture and control strategy were designed (figures 4). The automation was updated by re-designing the entire software including new parts coming from the existing relays logic. The most critical issues were the new control strategy for the entry looper cars (which both work in parallel), the tracking of welding, receipt management (level 2) and its interface with level 3.

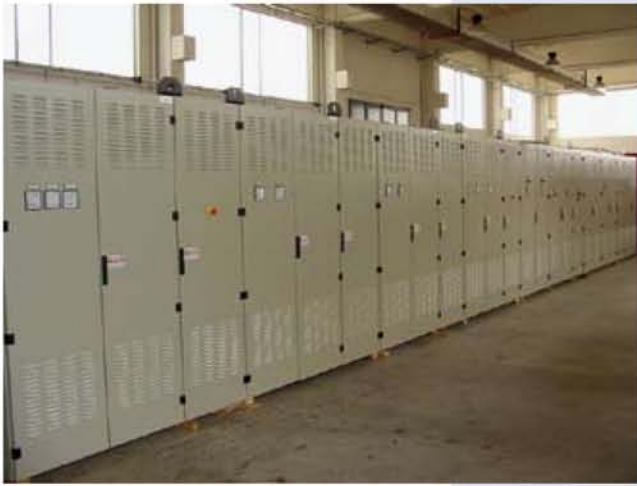
The new speed control by the new DC drives (figure 5) has eliminated the unnecessary switching off of the over-current protection upstream the drives, which had previously occurred about five times a week, resulting in around 15 minutes shutdown each time.

**Figure 5.**  
New automation  
equipment
